Case Study

Hydraulic Cylinders & Finish Issues

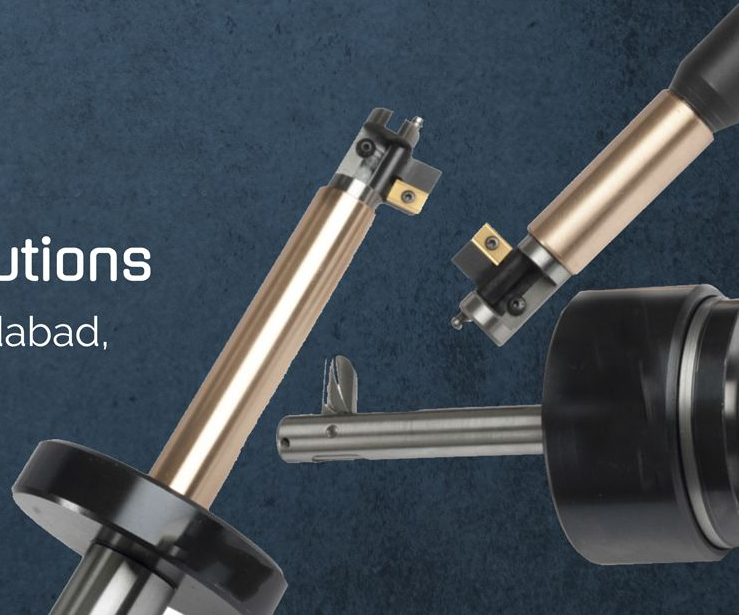
The original process consisted of (3) CT50 integral shank back boring bars. This tool used expensive inserts @ \$60 each that could only be ordered in packs of 50. The feature was a 70.75mm (2.785") bore reaching thru 55mm (2.17) to generate a 150mm (5.905") spot face. The spot face also had a 6mm (.236") corner radius and a 4.5mm x 45° ID chamfer. This feature was machined in 3 steps and produced surface quality inconsistencies with blends between the 3 steps. The Obtuz process machined the complete feature (ID Chamfer, Spot Face & Corner Radius) in a single pass. The Autofacer was run a 150 RPM and a feed rate of 0.8 IPM.
